# PERFORMANCE OF WEATHERING STEEL IN HIGHWAY BRIDGES

A Third Phase Report

American Iron and Steel Institute

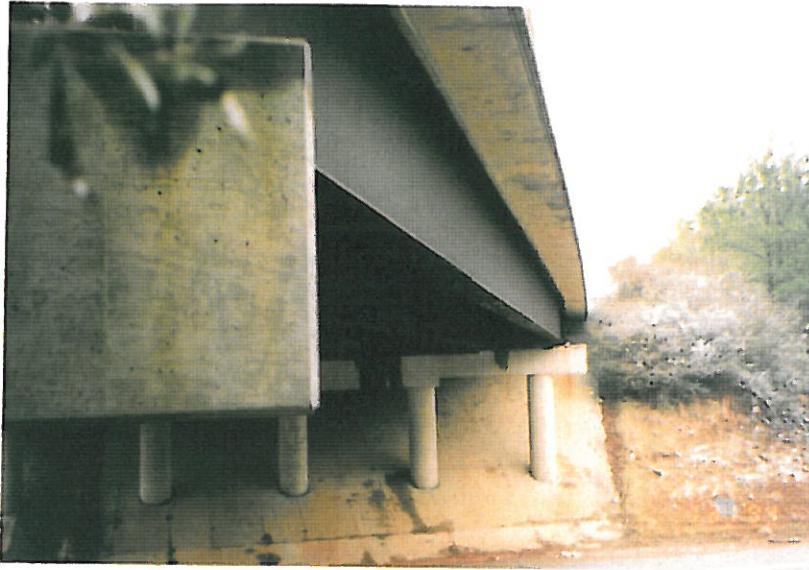
Grade separation bridges located over heavily traveled highways in Maryland, Wisconsin, New York, North Carolina and New Jersey sustained minimal, if any, corrosion on either fascia or interior girders as a result of the traffic passing below. Twenty-nine of the 63 bridges inspected were grade separation structures. Figures 4 and 5 show two examples of 18 and 23 year old steel girders, respectively.

Figure 4 - NC Route 231 over US 264; Nash County - Built 1976

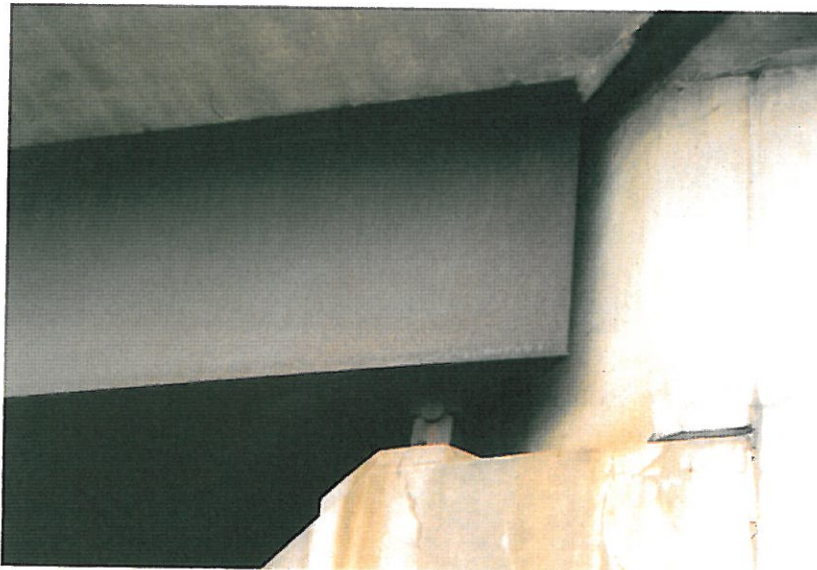
Figure 5 - MD Route I-895 over I-95; End of girder - Built 1970

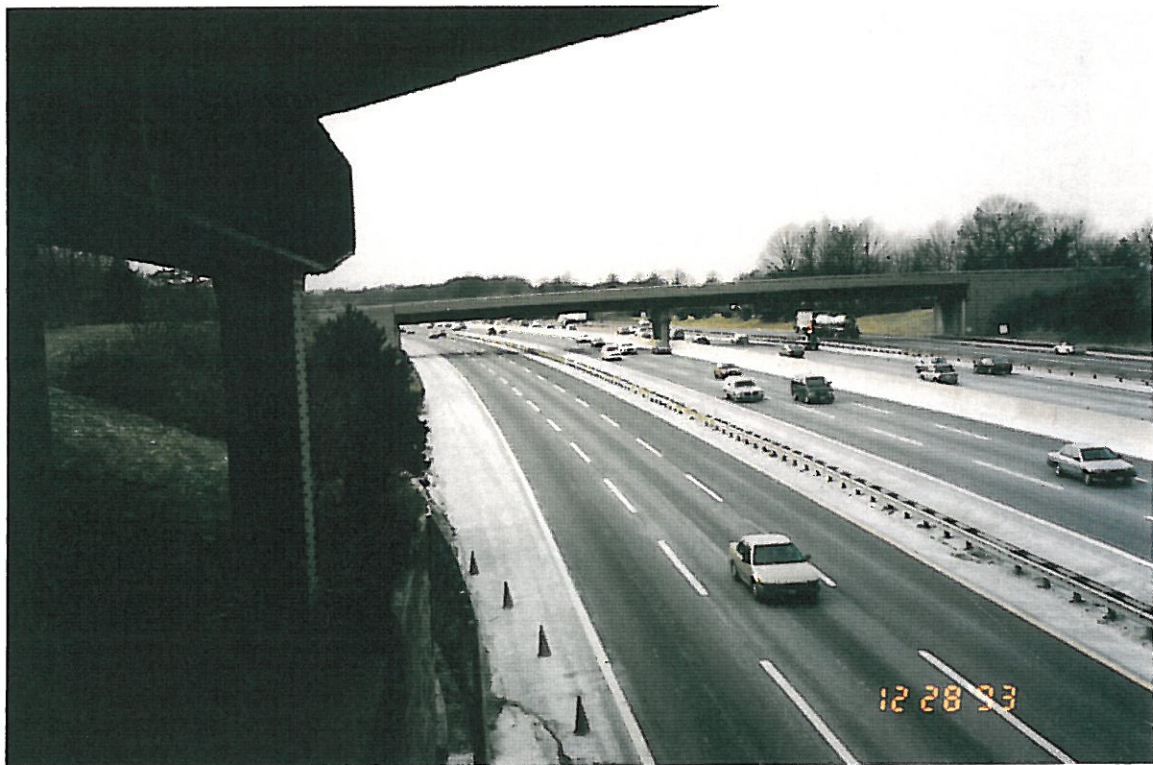
Most of these bridges, and the roadways below, have been subjected to appreciable amounts of deicing chemicals. Figure 6 shows deicing salts present on the roadway the day after an ice storm on the New Jersey Turnpike. The only exception to this finding is grade separation bridges in the Metropolitan Detroit area where significant corrosion was observed. As stated above, the difference in behavior between weathering steel bridges in the Metropolitan Detroit area versus bridges in other states may be related to the use of higher amounts and more frequent application of salt, the chemical composition of the deicing salt used, or a combination of these factors.

Figure 6 - New Jersey Turnpike; Salt on shoulders

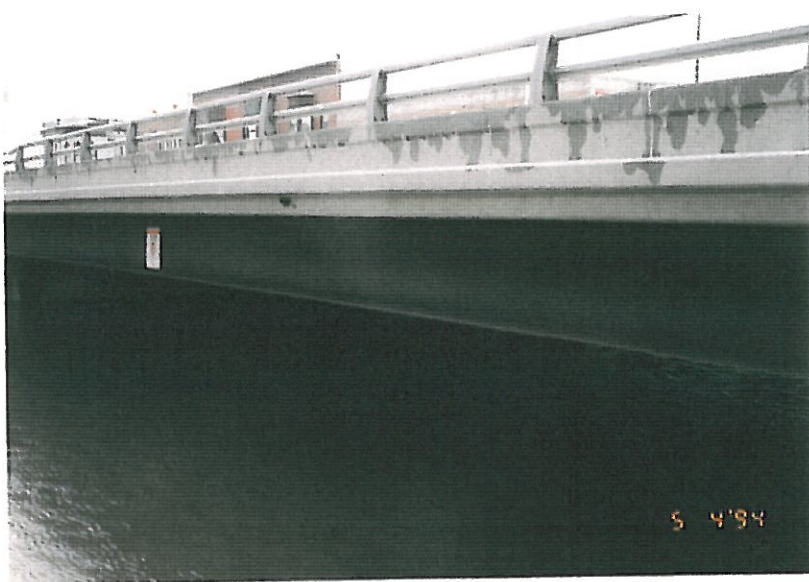
There was no visible evidence of unexpected corrosion taking place as a result of low-level crossings over either standing or flowing water. Figures 7 and 8 show two bridges constructed about four to nine feet above fresh water; neither one shows evidence of damage to the weathering steel used in their construction. The FHWA TA recommends at least a ten foot clearance for weathering steel structures over still waters and an eight foot clearance over moving waters. The results of this study, support a relaxation in the FHWA TA clearance requirements.

Figure 7 - Green Bay, Wisconsin; Four feet over still water - Built 1971

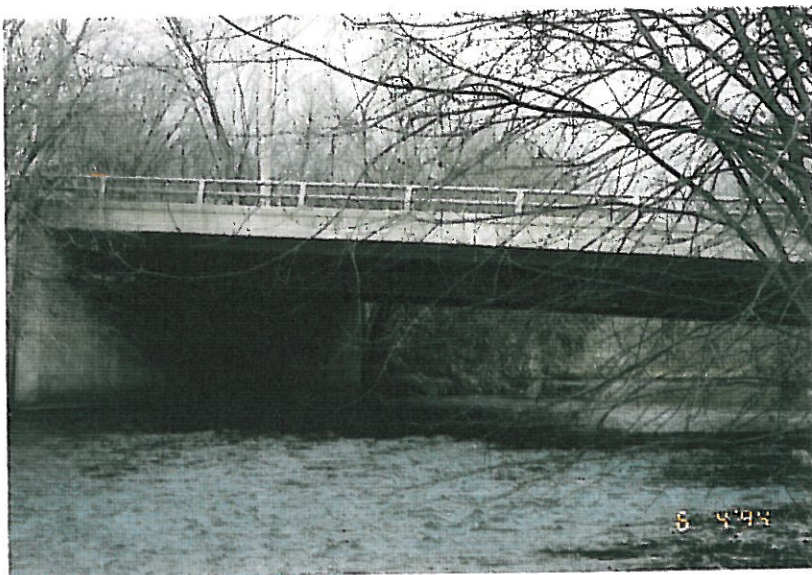
Figure 8 - Waukesha, Wisconsin; 6.5' to 9.5' over flowing water - Built 1972

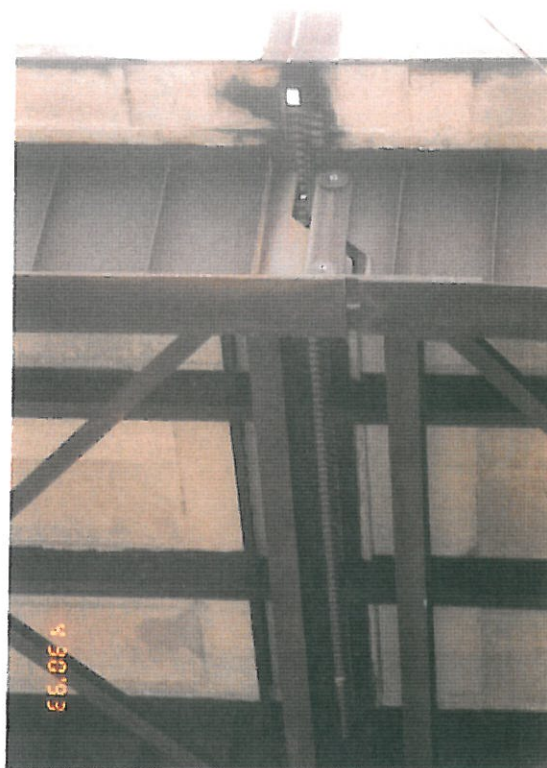
Figures 9 and 10 are illustrations of Bridge #50, located in the southern portion of Louisiana, immediately adjacent to the Gulf of Mexico. This bridge is partially painted due to an early concern for excessive corrosion; the remaining sections of the bridge are unpainted. Both the painted and unpainted portions of this weathering steel construction appear to be performing well. However, an additional investigation is being initiated at this site to quantify the performance of the unpainted weathering steel, and to compare the performance of the bridge members to test samples at the bridge site. Once completed, this study will provide additional guidance for this type of environmental exposure.

**Figure 9 - LA Route 23 over Doullut Canal - Built 1975**

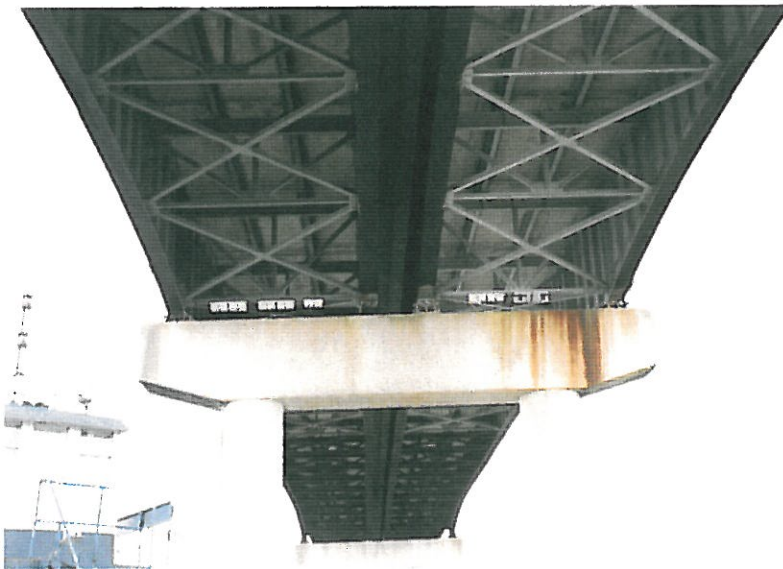
Figure 10 - LA Route 23 over Doullut Canal - Built 1975

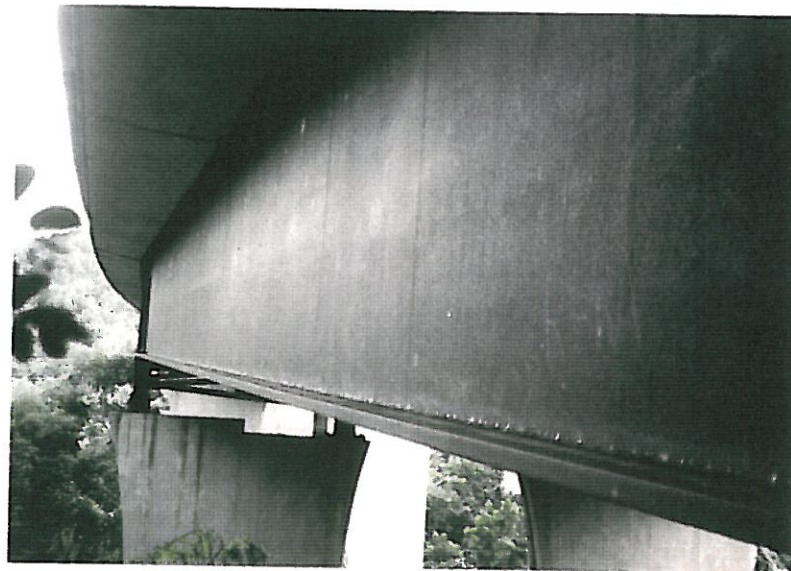
Several bridges included in this study have been exposed to these moisture conditions for more than 20 years and display no apparent effect from the high rainfall and ever-present high humidity. In this report, Figure 11 shows the condition of a steel girder of a typical bridge in Puerto Rico exposed to levels of rainfall that approach 70 inches per year as indicated by the U.S. Geological Survey Annual Rainfall map. In addition, two of the Puerto Rico bridges are in a location where there is a warning sign advising drivers of frequent dense fog conditions.

Figure 11 - PR Route 52; Bridge #2039 - Built 1972

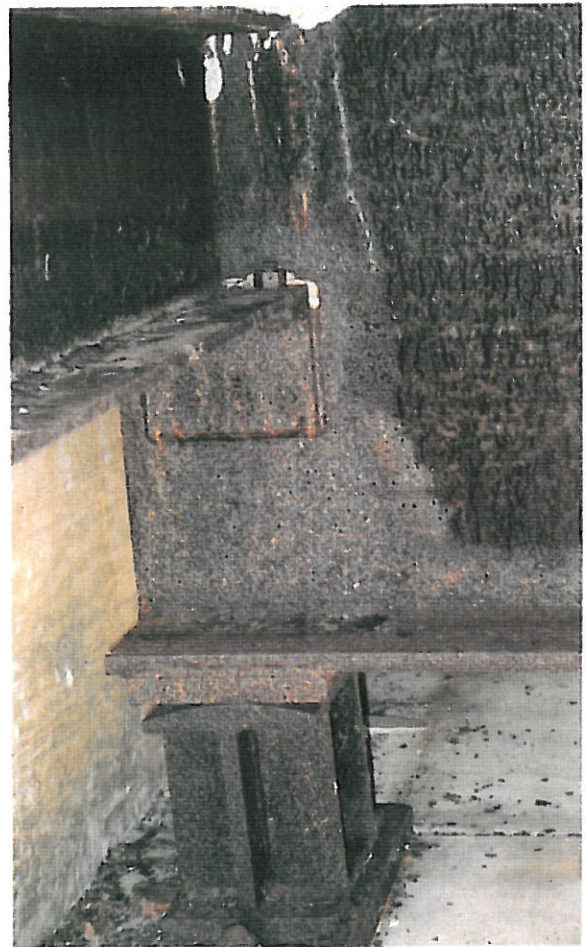
This study confirmed that inadequate control of drainage coming through bridge joints is the major cause of deterioration of steel and concrete bridge components where roadway deicing chemicals are used. Bridge joints inspected during this phase included simple hot-poured asphalt material, single-cell compression seals, strip seals, sliding plates, open finger joints, joints with and without troughs, and numerous other proprietary joint systems. Thirty-four, or 72 percent, of the highway bridges inspected had significant corrosion of the steel occurring under the joints, irrespective of the joint type. Figure 12 is a typical example of the excessive corrosion that has occurred under these leaking joints.

**Figure 12 - Illinois Bridge #61-0071 near Centralia;  
End of girder under joint - Built 1973**

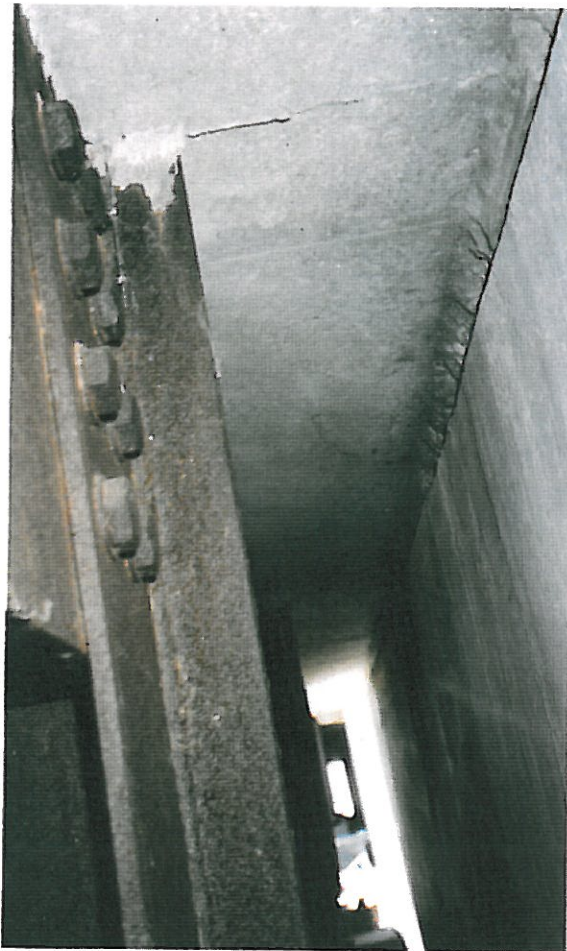
Figure 13 - NY Route 117 over US; Underside of deck at abutment - Built 1970

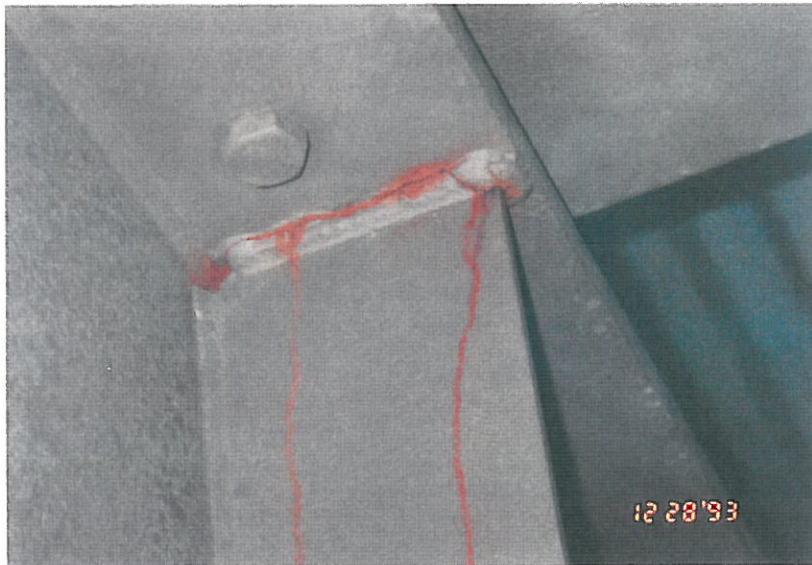
A concern expressed by some is the reduced capability to see fatigue cracks in weathering steel, increasing the probability of missing these cracks during inspections. Only one fatigue crack was observed in this study, and as can be seen in Figure 16, the fatigue crack is readily visible. In fact, fatigue cracks in weathering steel tend to bleed an orange dust that is easy to detect. However, as with any bridge inspection, adequate lighting is essential.

Figure 16 - Fatigue crack in weathering steel
