**Experimental Evaluation of
the Strength and Behaviour
of 16- and 18-Gauge Cold
Formed Steel Top Track
Systems**

RESEARCH REPORT RP05-4

**EXPERIMENTAL EVALUATION OF THE STRENGTH AND
BEHAVIOUR OF 16- AND 18-GAUGE COLD FORMED STEEL
TOP TRACK SYSTEMS - 92 MM AND 152 MM, 16''- and 24''-
SPANS (W & W/O 2X4 AND 2X6 WOOD TOP PLATES)**

**A Study Conducted at the University of New Brunswick Structural Engineering
Laboratory under the Supervision of J. L. Dawe, PhD, P.Eng.**

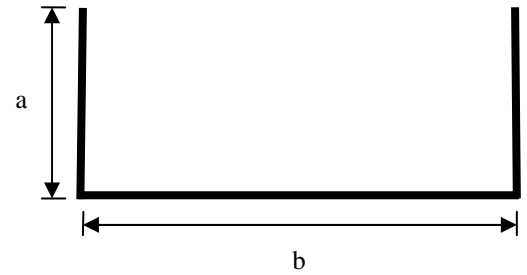
Table 3.2 – Track Dimensions

Designation	a(mm)	b(mm)
3 ⁵ / ₈ "	29.97	92.58
6"	29.97	152.91
DL	50.80	92.58

The three types of top track employed in this research included 3-5/8 inch standard track, 6 inch standard track, and 3-5/8 inch deep leg track. Table 3.1 lists the different test groups, the

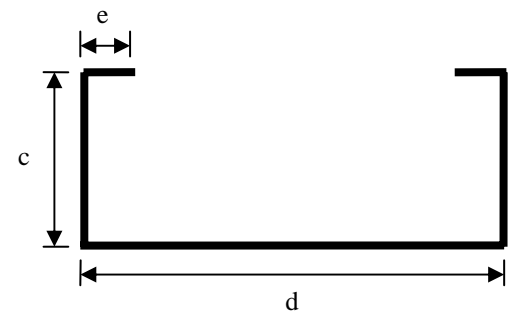
**Table 3.3 – Stud Dimensions**

Designation	c(mm)	d(mm)	e(mm)
3 ⁵ / ₈ "	41.28	92.08	12.7
6"	41.28	152.40	12.7

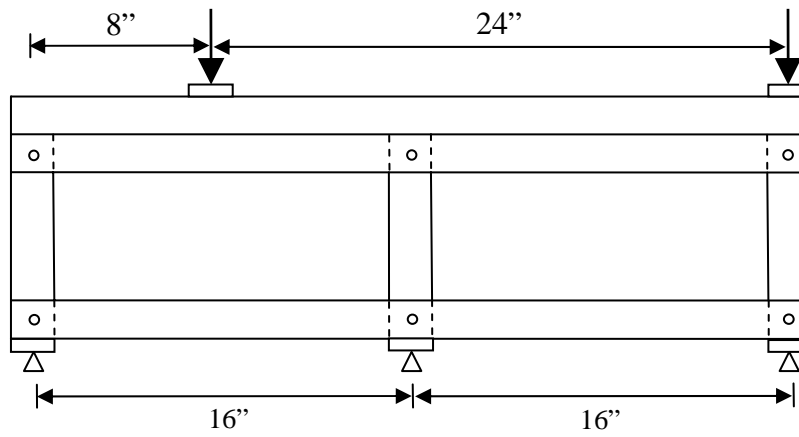
Figure 3.1 – Typical Test Setup of 16 Inch Specimen

Typical test set-ups are illustrated in Figures 3.1 and 3.2 which show the locations of the point-applied loads for the 16 inch and 24 inch stud spacing configurations. Figure 3.3 is a photograph of a typical set-up in the Baldwin UTM.

Each specimen was constructed as a frame consisting of three 8-inch long studs spaced at 16 or 24 inches and supporting a top track as described in objective A, B, C, D, or E. The assembly was completed by attaching a bottom track of the same specified size as the top track. Studs and track were connected with #8 hexagonal self-drilling screws. Standard 2x4 pieces of lumber were attached as required to top tracks using 3-inch long galvanized common nails. Stud spacing was either 610 mm (24") or 406 mm (16"). Typical specimens are diagrammatically illustrated in Figures 3.1 and 3.2.

A distribution beam was used to transfer equal loads from the load head to the points of load application of each specimen. Reaction plates measuring approximately 18x50x250 mm were placed between each point of load application of the distribution beam and the test specimen. A W200x36 steel section was utilized as a support reaction beam for the majority of specimens. Due to various laboratory demands, it was necessary to replace this beam with a C230x30 steel section for all specimens under Objective C with the exception of specimen 1C16-16.

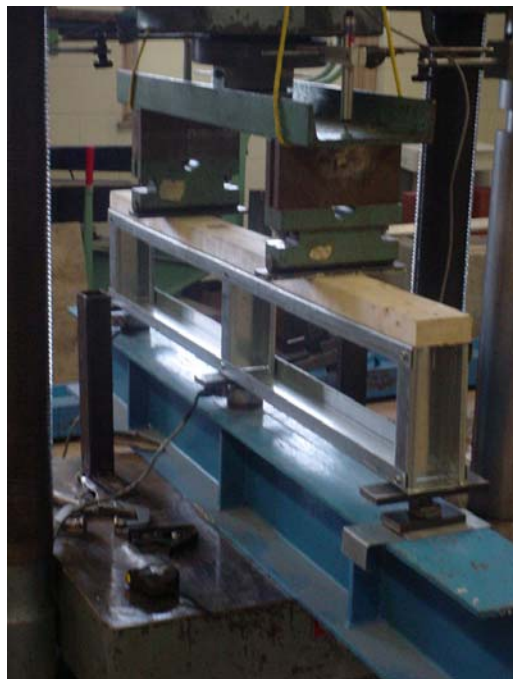
Figure 3.3 – Typical Test Setup Showing Placement of LSCs and Load Cells

As shown in Figure 3.3, load cells were placed between two of the specimen supports and the platen of the UTM while a ball and socket joint was used to support the specimen at the third support point. Linear strain converters (LSCs) were used to measure deflections. Two LSCs were placed so as to measure downward movement of the distribution beam and another was positioned on the platen to track its progress upward. Steel restraints were placed at either end of the specimen to prevent in-plane and lateral movement.

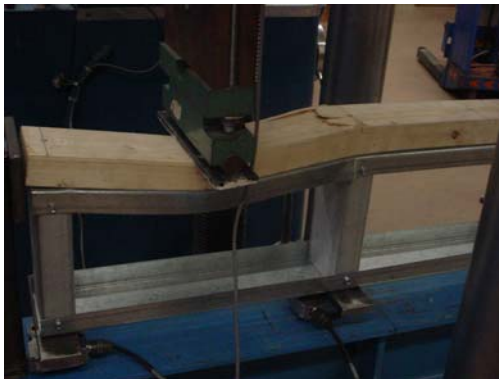
Figure 4.1 – Failed specimen, Group A16-16

Specimen 1A16-16 developed a slight bowing of the top track leg over its length and subsequently failed at ultimate due to tensile fracturing of the wood at mid-span. The specimen continued to deform without taking additional load as local buckling of the track legs developed at the central support in the compression zone followed by failure of the wood in the tension zone at this negative moment location. The ultimate failure of specimen 2A16-16 and 3A16-16 also occurred as a result of tension failure of the wood at mid-span followed by tensile fracturing of the wood and leg local buckling at the central support as the deformation increased and the load dropped off. The photograph in Figure 4.1, taken after failure, illustrates a typical failure mode for this specimen group.

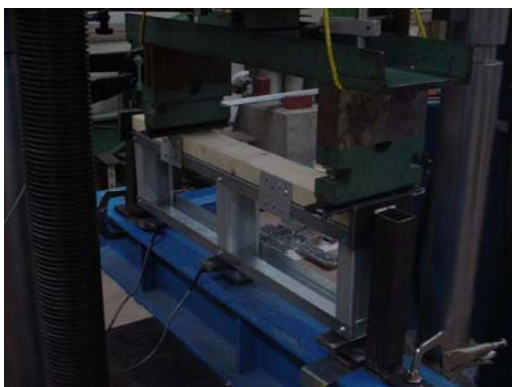
Figure 4.3 –Specimen 2A16-18 with shear plates

The shear connection between the wood and top track for specimen 2A16-18 was varied and consisted of steel plates fastened to the wood and steel track as shown in Figure 4.3. This specimen failed almost identically to specimen 1A16-18, although the shear connection was less efficient, and there was separation of the wood from the steel as indicated in Figure 4.4. For graphing purposes, specimen 2A16-18 was excluded as the shear connection was fundamentally different from that of the other specimens in this group.

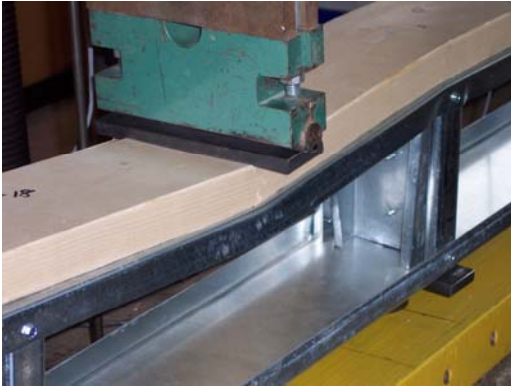
Figure 4.9 – Deformation of Specimen 2C16-16

Specimens in this group reacted similarly to those tested previously in Specimen Group C16-16. At approximately 80% of the maximum load specimens began to show noticeable signs of buckling near the middle support. As this buckling became more distinct, a tension crack

began to form in the wood at midspan and above the middle support as ultimate was approached. Figure 4.9 shows specimen 2C16-16 near the end of testing.

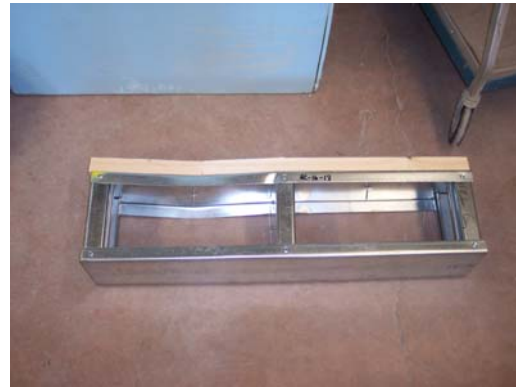
Figure 4.10 – Preferential Span Deflection, Specimen 2C24-18

Specimens in this group, which consisted of lighter gauge steel, began buckling at the middle support at around 50% of the ultimate load. Ultimate capacity was determined by cracking of the wood shortly after the legs of the steel top track began to buckle. The wood fractured in the flexural tension zones at the middle support and at each point load. As is often the case for symmetrical test specimens, as ultimate load is approached, accentuated preferential deformation occurs under one of the two symmetrical loads. This is evident in Figure 4-10 for example. As can be understood, this is not indicative of unequal loads being applied throughout the test, but rather that near ultimate, the randomly weaker of the two spans shows significantly more deformation.

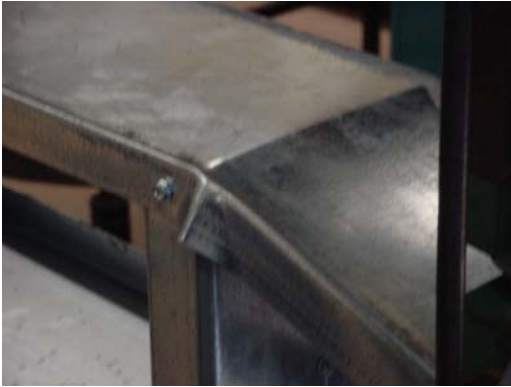
Figure 4.11-Buckling at Central Support

The track legs of the specimens in this group began to buckle at the middle support before any significant deformation was noted at the midspan. As the support buckling progressed, deflections at midspan became more pronounced and ultimate capacity became imminent. Severe deformation occurred at the middle support as shown in Figure 4.11.

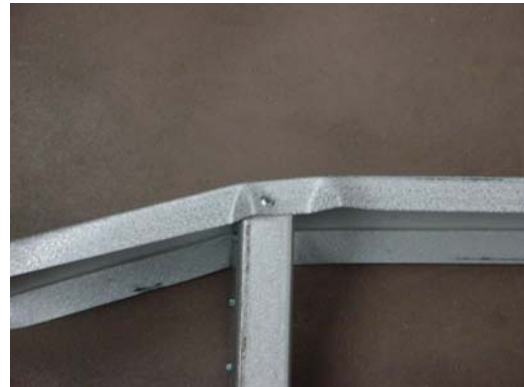
Figure 4.12-Failure of 18-ga. track

The specimens in this group acted in a manner very similar to those of Group D16-16. Buckling was noted at the middle support followed by deformation at midspan as load increased. Near ultimate, severe deformations of the top track developed at the central support as can be seen in Figure 4.12.

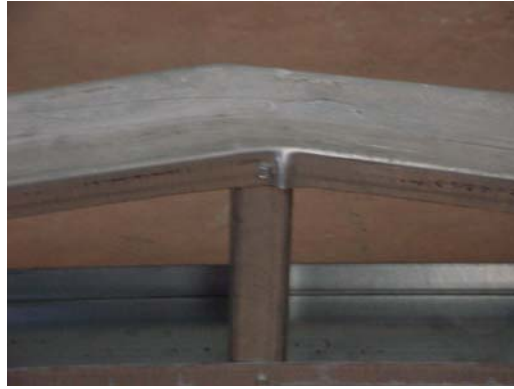
Figure 4.13 – Failure of Specimen 3D24-16

At approximately 95% of the ultimate load, the specimens yielded after which followed by ductile behaviour and a slight load increase as deformations became significantly noticeable. An example of a failed specimen, 3D24-16, is shown in Figure 4.13. Buckling of the top track legs was especially noticeable in this specimen.

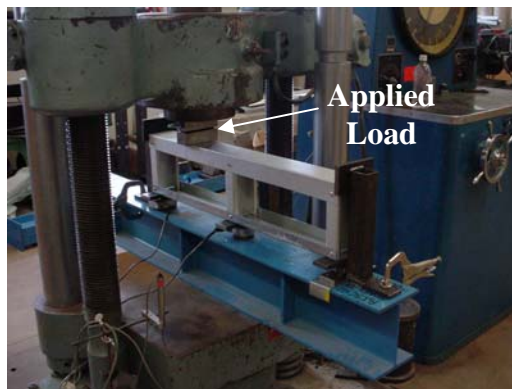
Figure 4.14: Failed Specimen 1E16-18

The setup for specimen 1E16-18 and 2E16-18 is shown in Figure 4.14. A bearing failure initiated under the point load at approximately 50% of the ultimate load. Near ultimate load, the

far stud started to lift off of the support and local buckles formed on the legs of the bottom track near the centre stud. A failed specimen for this configuration is shown in Figure 4.14.

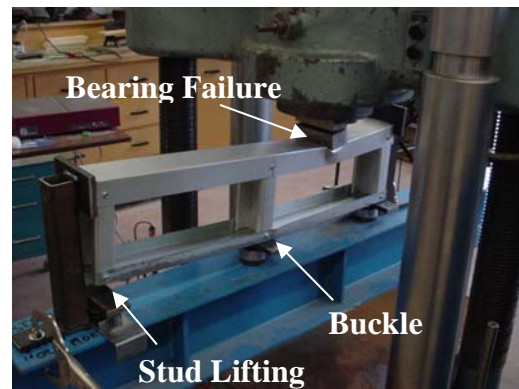
Figure 4.15 – Failed Specimen 4E16-18

Specimens 3E16-18 to 5E16-18 were tested using the two load point configuration, as used for all other tests. The initiation of bearing failure was first noticed at approximately 50% of the ultimate load at the location of the mid-span load point. This was followed by the start of local buckling in the legs of the top track near the centre stud. Each leg of the top track had two buckles start to form symmetrically around the centre stud. A failed specimen is shown in Figure 4.15.
