FINAL REPORT

**PERFORMANCE OF
WEATHERING STEEL BRIDGES
IN WEST VIRGINIA**

WVDOT/DOH Research Project

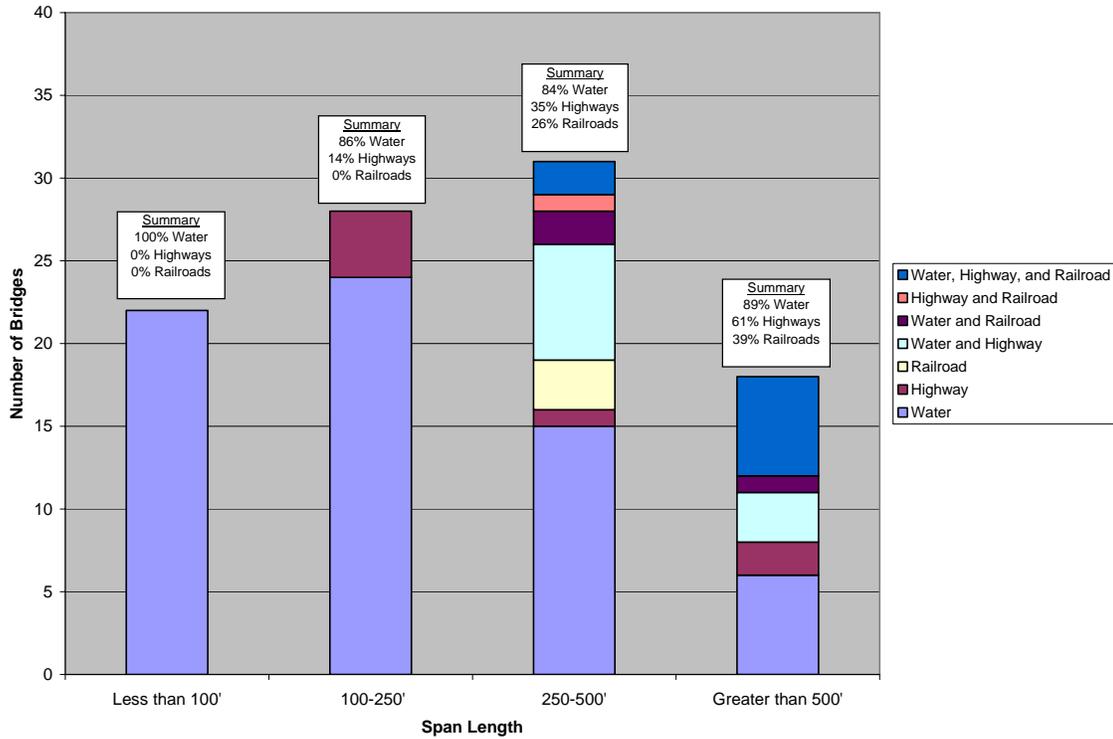
Figure 3 Categorization of WV Weathering Steel Bridges by Length and Crossing

in each of these four categories. Each category has a significant number of bridges. Fig. 3 also shows the relationship between length and crossing type. Bridges with shorter spans tend to cross over water only, while bridges with longer span lengths tend to also cross over highways and/or railroads.

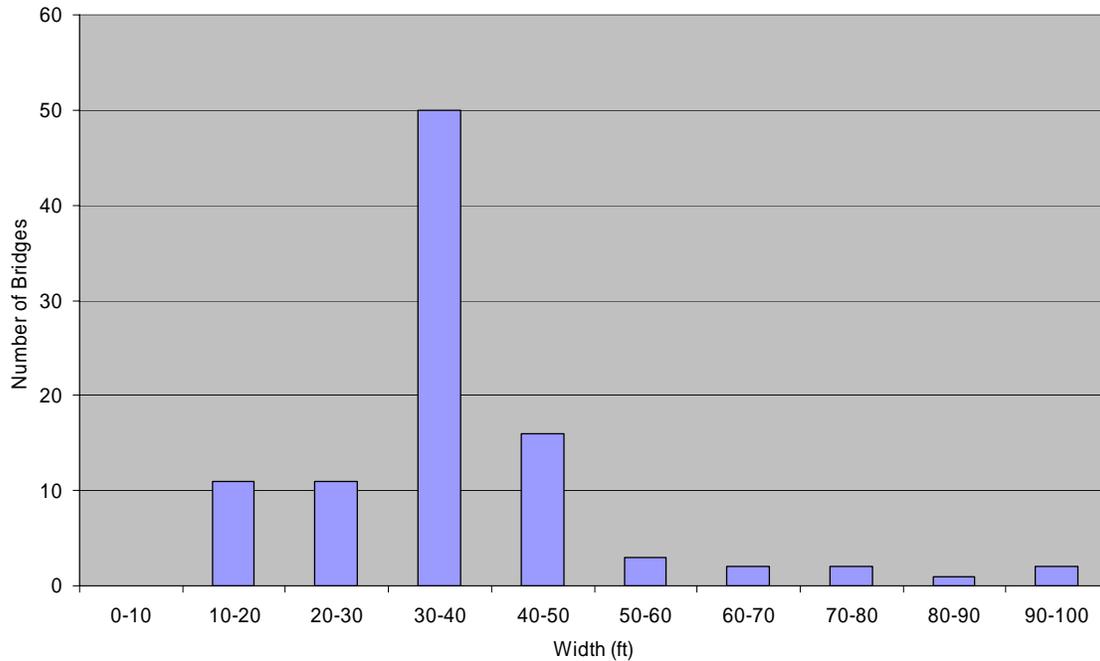
Figure 4 Categorization of WV Weathering Steel Bridges by Width

The weathering steel bridges are also classified by width (in 10-ft increments). As shown in Fig. 4, the majority of the bridges have widths between 30 and 40 ft, and 90% of the bridges have a width less than 50 ft. These results indicate that most of the weathering steel bridges are two-lane bridges.

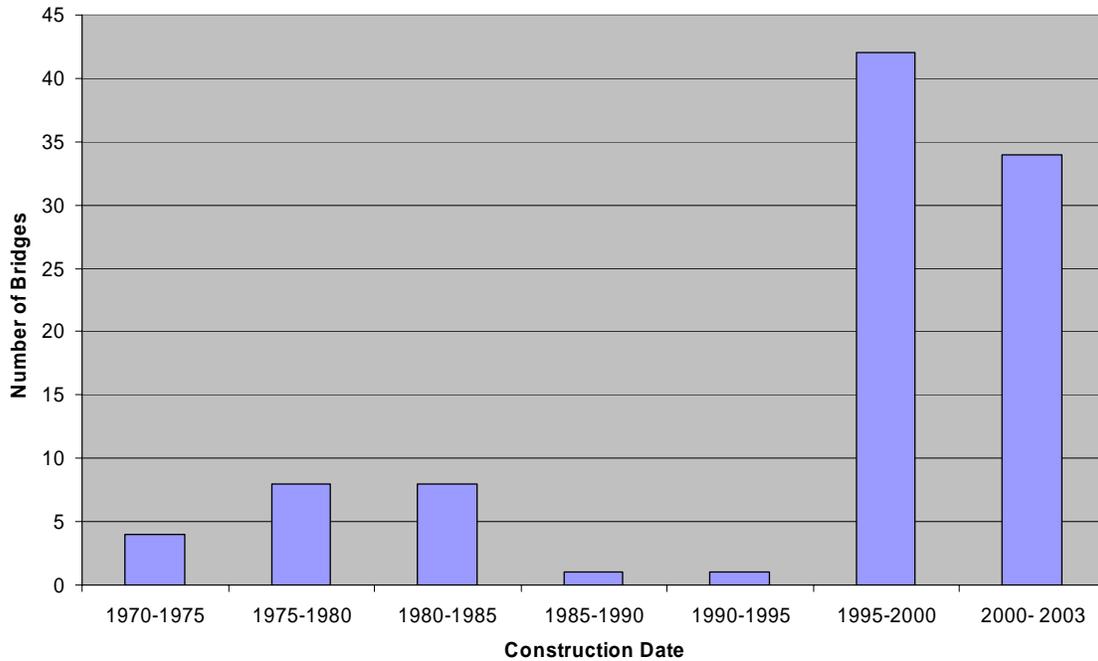
Figure 5 Categorization of WV Weathering Steel Bridges by Construction Date

The age of the weathering steel population is shown in Fig. 5. The age of these bridges is consistent with past and current trends in the development of weathering steel. The oldest weathering steel bridge in the state was built in 1971 when weathering steel was first starting to emerge in bridge applications. A total of 20 bridges were then built prior to 1985 when concerns regarding acceptable performance of weathering steel in some environments became publicized; consequently, only two weathering steel bridges were built in the ten-year period between 1985 and 1995. Weathering steel is again gaining popularity, and a large number of the weathering steel bridges (76) have been constructed in West Virginia within the last ten years. The most current category of construction dates ranges from 2000 to 2003 (when this project was initiated). Therefore, the decreasing trend in the number of weathering steel bridges being constructed, which is

shown in Fig. 5, is not necessarily occurring because the most current data are based on a shorter period of time compared with the other categories of construction dates.

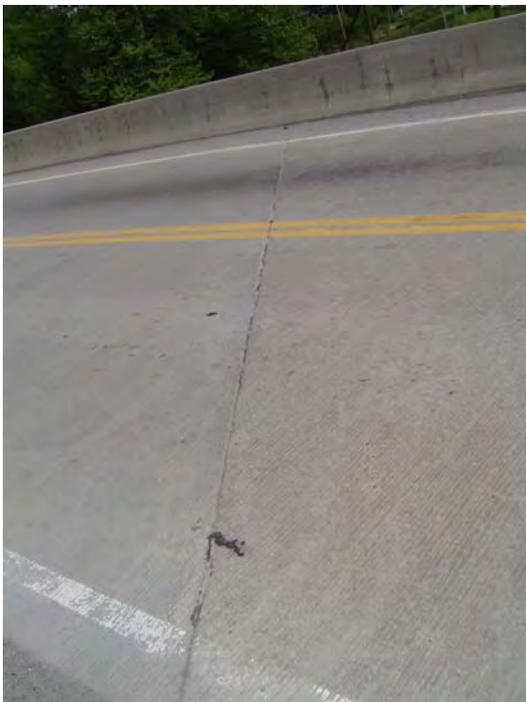
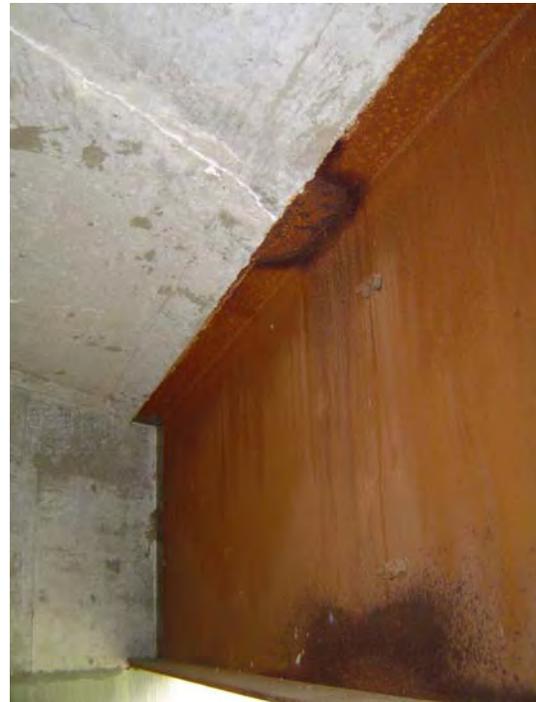
Figure 6 Corrosion Caused by Open Deck Joint

does not reach the steel elements below. These two factors reduce the rate of corrosion. However, when cracks or inadequately sealed construction joints are present in the surface of the deck, corrosion problems frequently occur beneath these cracks and joints. One such situation is shown in Fig. 6

(a) Deck Joint

(b) Corrosion Beneath Joint

Construction joints in concrete decks should be grouted. These joints should be carefully inspected during biennial inspections to monitor water penetrability. Construction joints located approximately 10 ft from the abutments were observed in many newer bridges. Design practices should be revised to eliminate these joints.

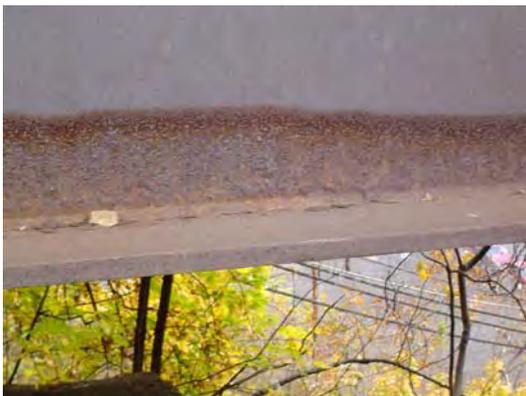
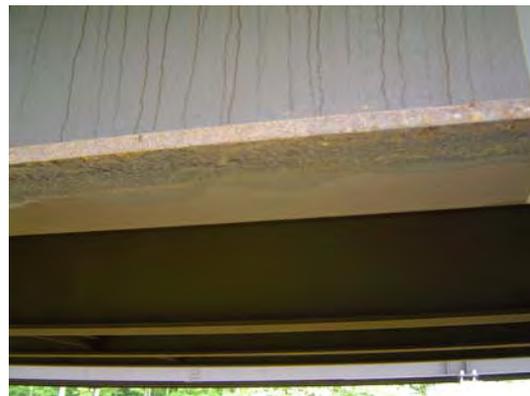
Figure 7 Corrosion due to Narrow Overhang

Concrete decks with relatively wide overhangs exhibit significantly less corrosion on the exterior girders. Corrosion on the bottom flanges and on the bottom of the webs of exterior girders is common in cases where the depth of the girder is greater than the width of the overhang. The corrosion is caused by the lack of shelter to the exterior girder. The horizontal surface of the bottom flange then allows water to accumulate, and capillary action draws this moisture up the height of the web. An example of this situation is

shown in Fig. 7a. This water also flows along the bottom surface of the bottom flange leading to corrosion, as depicted in Fig. 7b.

(a) Corrosion of Bottom Flange and Web

(b) Corrosion of Bottom Flange

The overhang width should be extended as wide as feasible to provide additional shelter to exterior girders. This recommendation is based on the high number of girders that had corrosion on the bottom flange and on the bottom of the web of the exterior girders. Inspection results suggest that this problem can be avoided when an overhang width equal to at least the depth of the girder is provided.

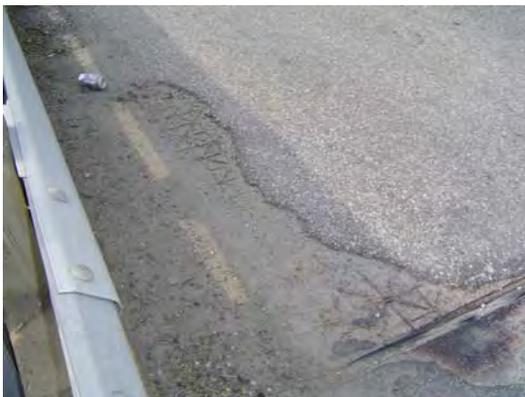
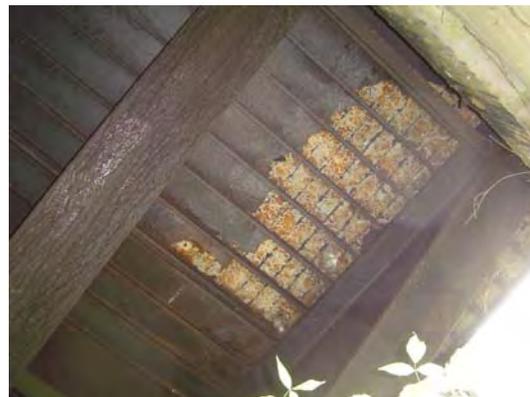
Figure 8 Concrete-Filled Metal Grid Deck

of bridge deck are shown in Fig. 8. The figure shows that this deck type consists of three components: a geometric steel grid, a stiffened bottom plate, and the concrete in-fill. Water is able to pass through the filled grid deck, which eventually deteriorates the underlying stiffened plate and allows run-off to flow over the weathering steel members. Thus the weathering steel is frequently exposed to moist conditions, which results in excessive corrosion.

(a) Grid Deck From Above

(b) Grid Deck From Below

Bridges should have decks consisting of a continuous, solid surface. Reinforced concrete decks with or without stay-in-place metal deck forms are recommended. Conversely,

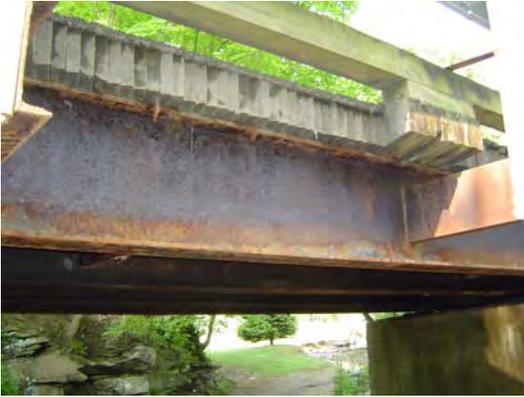
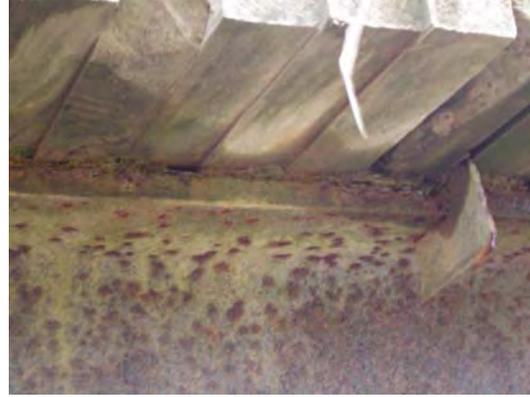
Figure 9 Typical Corrosion on Bridges With Timber Decks

All of the inspected bridges having timber decks displayed serious corrosion issues. Similar to the problems with concrete-filled metal grid decks, water easily penetrates between each joint of the timbers, providing little shelter to the weathering steel. Furthermore, the timber deck also retains moisture, which worsens the already severe corrosion of the top flange. Fig. 9 shows typical corrosion of a weathering steel bridge with a timber deck. It should be noted that many of these bridges have been painted, and the paint systems are also failing.

(a) General View

(b) Pack Rust on Top Flange

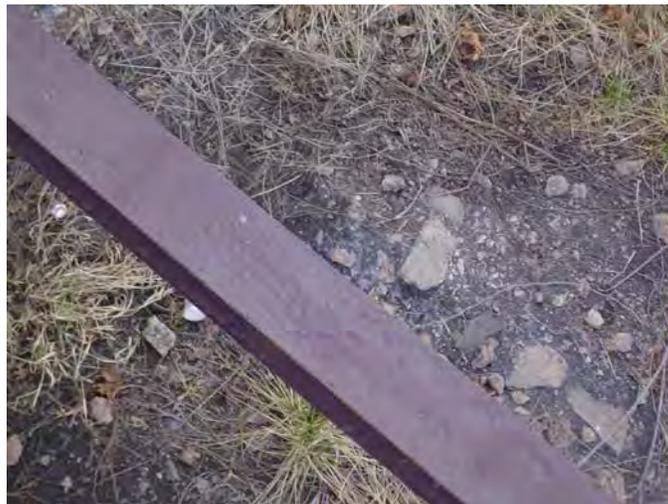
Figure 10 Horizontal Member of Deck Truss

Arch and frame bridges contain an unavoidable negative aspect because numerous members are completely exposed to the elements. This type of bridge has three problems: (1) ponding of water can occur on the horizontal members, (2) the orientation of inclined members, particularly at the bearings, allows water to collect in places that do not have any mechanisms for drainage, and (3) open cross-sections allow moisture to enter the section, particularly in combination with the connections. Examples of each of these three conditions are shown in Figs. 10-12. Fig. 10 shows a heavily pitted horizontal member of a steel deck truss. Fig. 11 shows the bearing of a steel frame, which was filled with debris immediately before this photograph was taken. The accumulated debris and moisture lead

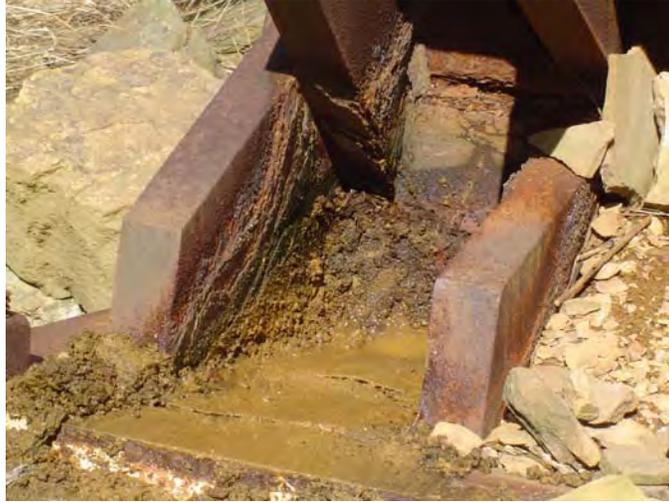
Figure 11 Bearing Corrosion on Steel Frame Bridge

to significant bearing corrosion, as shown in Fig. 11. The excessive corrosion in the interior of an open truss member is shown in Fig. 12. The substantial corrosion of the bottom bolts are also shown in this figure.

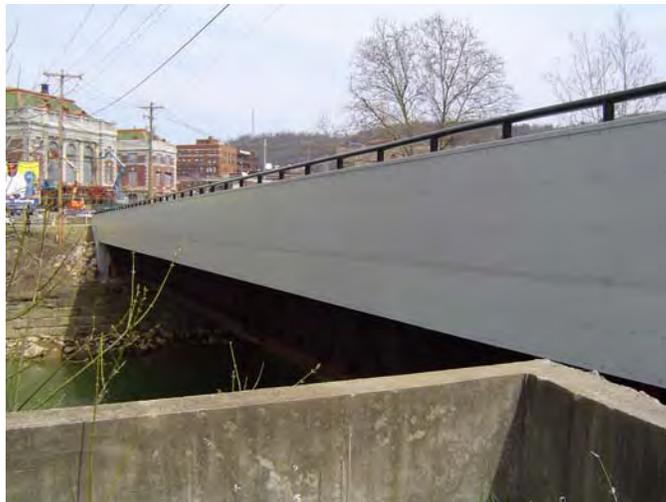
Figure 13 FRP Panels Sheltering Exterior Girders

displayed decorative FRP sheets on the exterior surfaces (see Fig. 13). These sheets provide a significant increase in the amount of shelter given to the exterior girder. Such an approach may be adopted in future efforts to minimize corrosion of the exterior girders.

As previously mentioned, as a rationale for providing relatively wide overhangs, the exterior girders are typically subjected to the elements to a higher degree than the interior girders. Consequently, increased corrosion typically results in exterior girders. This situation can be prevented by providing wider overhangs; however, this method may not be feasible for girders with large web depths. A novel approach to this problem was encountered during the inspection of a weathering steel bridge with a fiber-reinforced polymer (FRP) deck. In addition to the structural FRP components, this bridge also
