## **Galvanized Steel Framing for Residential Buildings**

**RESEARCH REPORT RP06-1**

# **ILZRO RESEARCH PROGRAM ZC-4**

### **7-Year Report**

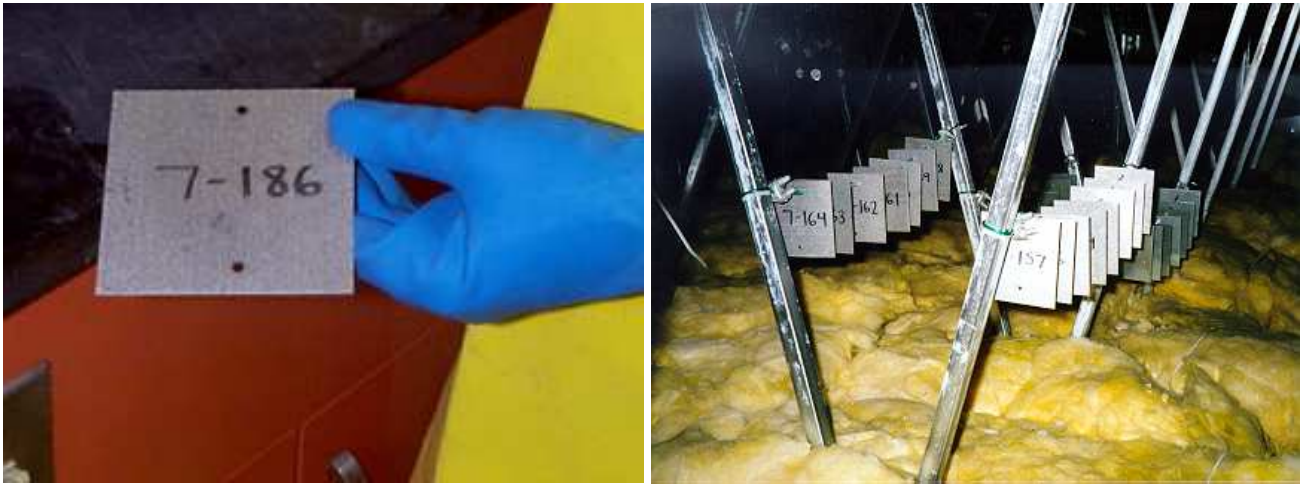
**Figure 1 – Plate Samples**

The corrosion samples consist of galvanized, galvalume, and galfan coatings in the form of 10 cm x 10 cm (3.94 in x 3.94 in) flat plates and 1-inch (25.4 mm) (nominal) segments of C-section stud. The flat plates allow for a more definitive determination of the specimen's area, and thus a better measure of coating thickness and mass reduction after exposure (Figure 1). The C-section samples have been installed to investigate corrosion performance at the edges and bends of a stud. Both the plate and stud samples have both sides and all edges exposed, which is consistent with the approach used in parallel research efforts in France. The coating thickness specifications for the samples are listed in Table 1.

Knowing the exact dimensions of these coupons provides an accurate determination of coating thickness reduction when the samples are retrieved and analyzed. The stud-type samples are one-inch (25.4 mm) nominal segments of 3-5/8 inch (92.1 mm) (web dimension) C-section studs. The area of these samples cannot be exactly determined; however, their weight loss due to corrosion can be determined upon retrieval. The stud type samples also provide a visual evaluation of any corrosion that may occur at edges or bends of rolled studs.

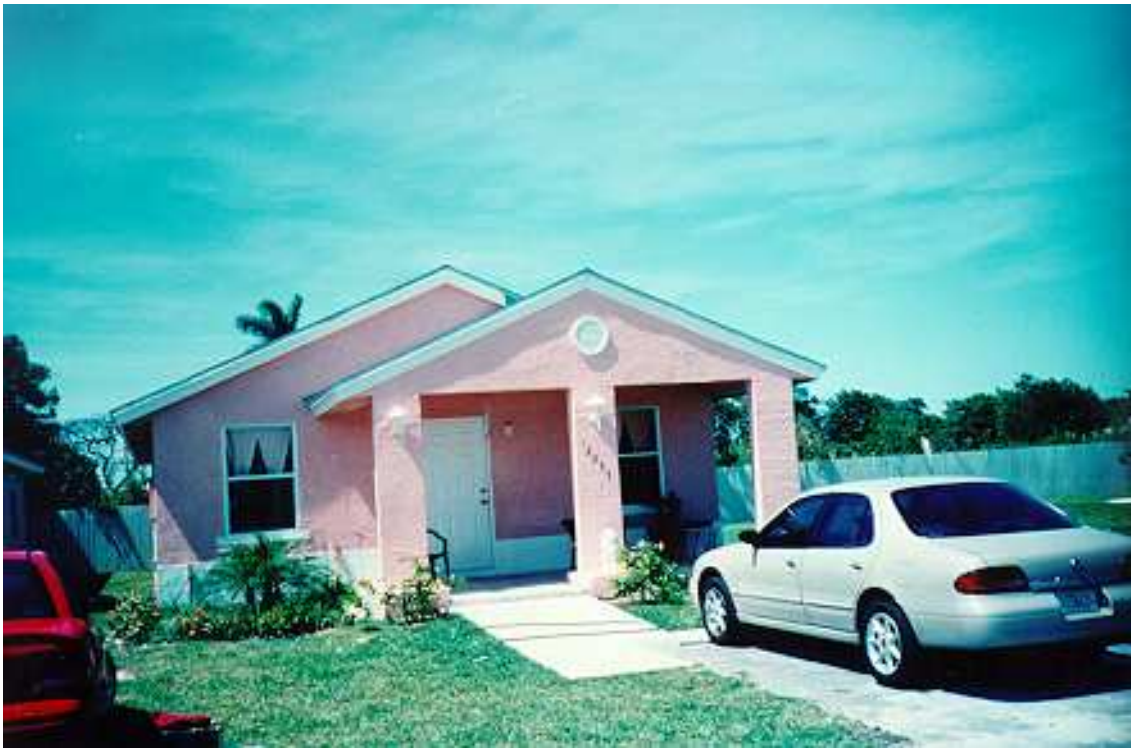
**Figure 2 - Miami, Florida Corrosion Site**

The Miami site (Figure 2) is in a Habitat for Humanity Development in southwest Miami, where 16 of the 90 homes have been framed with steel systems. The site is a single-story steel framed structure with a slab foundation. It has plywood sheathing with a stucco exterior finish. The wall interior is 5/8" (16 mm) painted drywall. The attic has kraft faced (facing the drywall) fiberglass batts with an R-30, while the walls have either R-11 or R-13 batts. The walls are 6" (152 mm) wide. The attic is vented with soffit vents (19 vents total, each is 22" x 4"). No ridge vents are present, and one small gable end vent is visible in the front of the house.

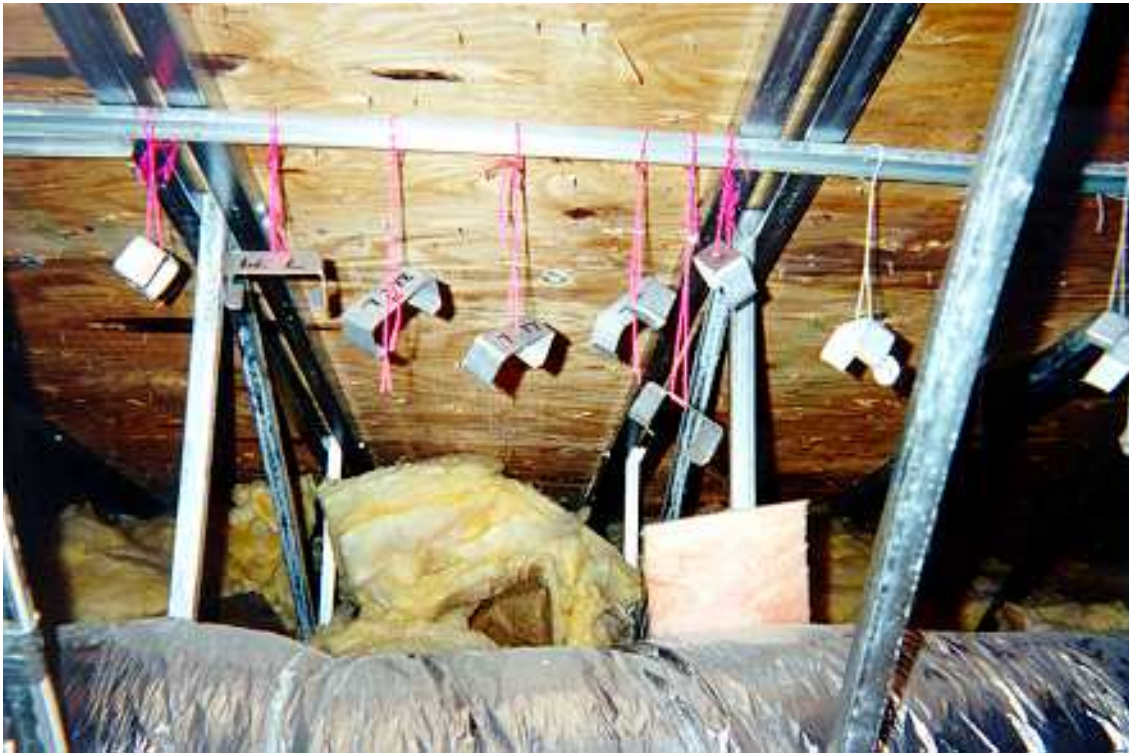
**Figure 3 – Attic Specimens in Miami, Florida Site**

Sample colonies were located in both the attic (see Figure 3) and an exterior wall. The attic colony contained samples that were suspended from the roof framing. This stock of samples includes galvanized, galfan, and galvalume plates and studs. A small quantity of bare samples was also installed. The attic is vented by soffit vents on the east and west sides of the house.

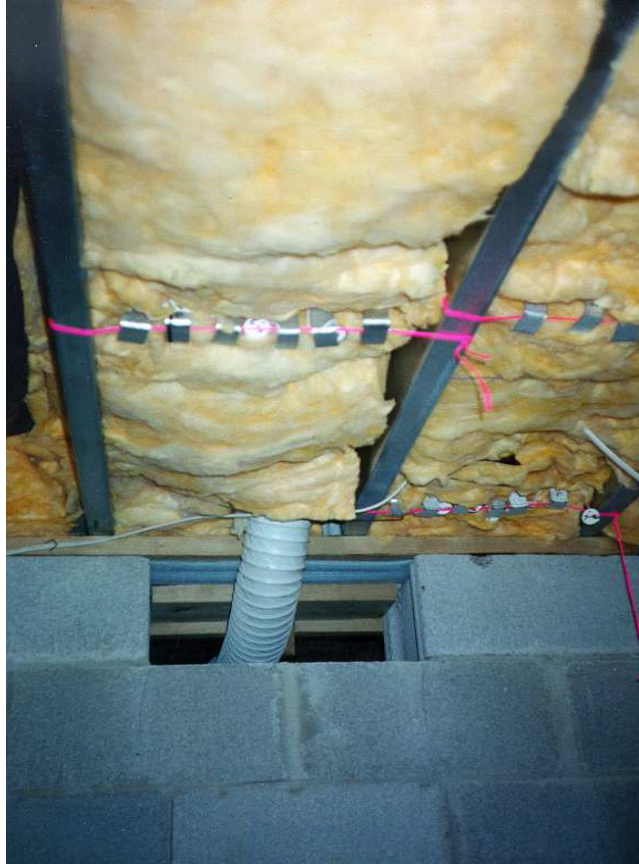
Figure 5 - Crawlspace Specimens Embedded in Floor Insulation

The crawlspace contained a set of suspended samples and another set that was partially embedded in the fiberglass batts between the joists (see Figures 5 and 6). The suspended set was fully exposed to the ambient crawlspace environment, and contained plates of all three coating types. Galvanized, galvalume, galfan, and bare (stripped) stud-type specimens were also suspended. The bare samples displayed extensive corrosion after just two months of exposure, indicating the aggressive environment in the crawlspace (see Figure 7). The set that was partially embedded in the floor insulation contained galvanized and galvalume stud samples. Their installation was designed to duplicate the exposure conditions of a floor joist.

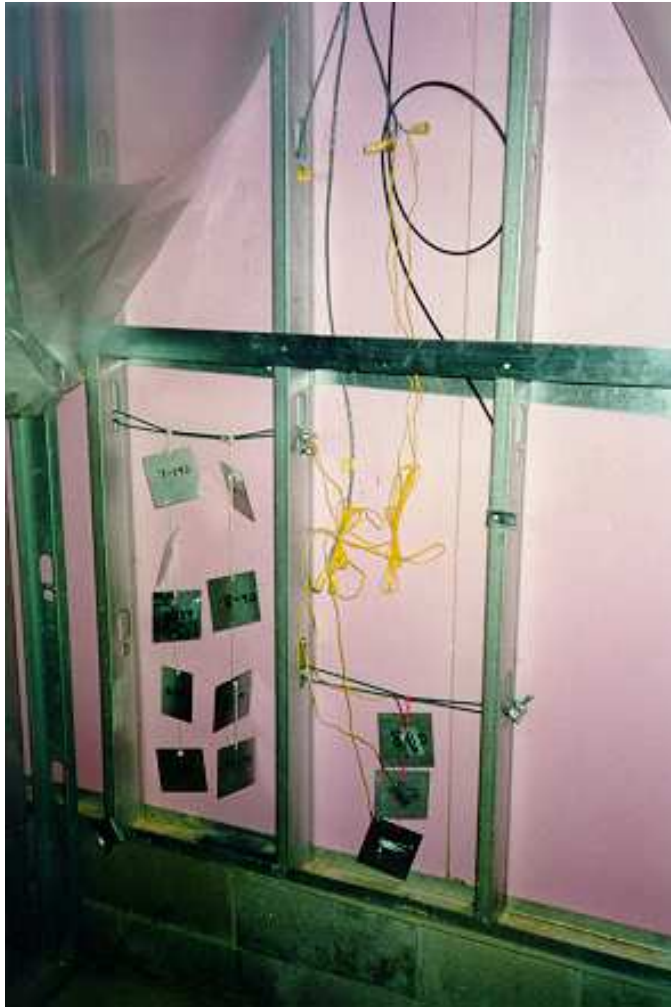
**Figure 10 - Wall Cavity Specimens and Sensors in Hamilton, Ontario, Site**

The exterior wall colony in the Hamilton house was located in the basement's framed wall (see Figure 10). Galvanized, galfan, and galvalume samples were installed in the wall. As in the attic, thermistors were installed to monitor the surface temperature of the three sample types, and two additional sensors monitored the temperature of the wall's base plate and a steel wall stud. The wall cavity ambient relative humidity and temperature was also recorded. Lastly, a time of wetness sensor was mounted to a wall stud to quantify the frequency of condensation on the stud.
