# PERFORMANCE OF WEATHERING STEEL IN HIGHWAY BRIDGES

A Third Phase Report

American Iron and Steel Institute

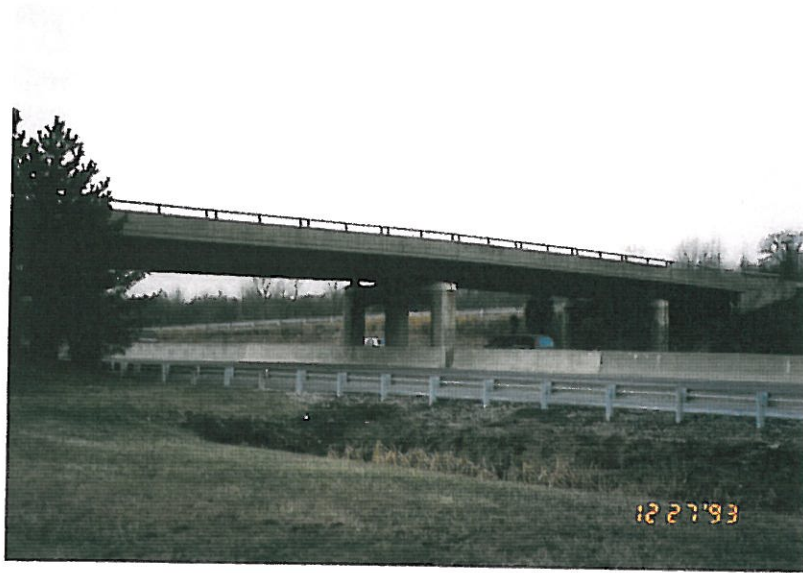
**Figure 2 - Moorestown Interchange; New Jersey Turnpike - Built 1964**

For these reasons, engineers and owners have chosen weathering steel over other materials in highway bridges. The first bridge using weathering steel was built over the New Jersey Turnpike in 1964 (Figure 2). At approximately the same time, the Eight Mile Road Bridge was built in Michigan. While New Jersey was pleased with the performance of its weathering steel bridges, Michigan found the material to be performing poorly, specifically in the Detroit Metropolitan Area (Wayne County). Poor material performance in Detroit led the State of Michigan to issue a moratorium on the use of weathering steel for highway bridges of all types throughout the State. This action led other states to question the suitability of weathering steel in highway bridge construction. These concerns led to the Phase-I investigation spearheaded by the AISI. The Michigan moratorium was lifted in 1990.

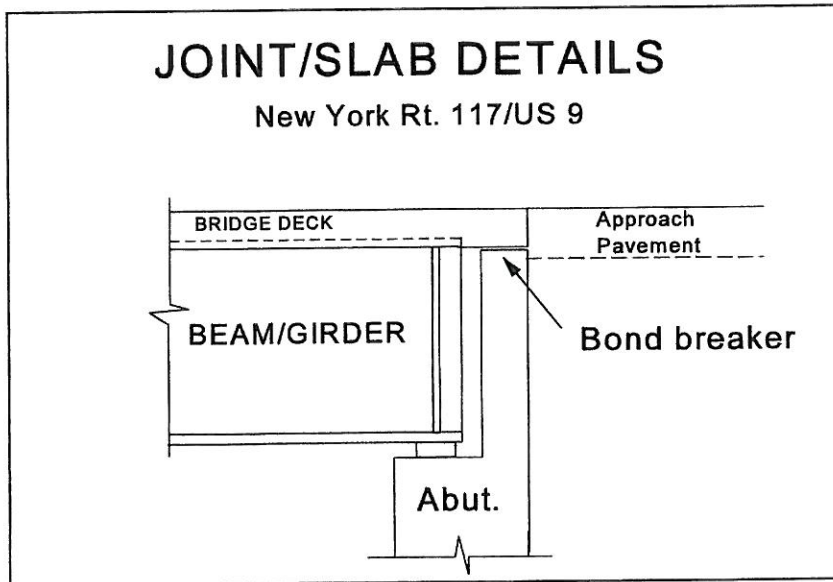
Figure 14 - Graphic of NY 'Jointless' Deck

In three states, some of the bridges inspected were “jointless” and, therefore, had no problems related to joint leakage. The deck slabs in these bridges were detailed such that there was no need for a traditional joint at the bridge abutments. Figure 13 shows a typical bridge detail, and Figure 14 shows it graphically. The bridges inspected with these “jointless” details were on the order of 200 feet and longer. Figure 15, distribution of bridges by span length and total length in the United States, shows that 80 percent of the nation's 575,000 bridges are only 180 feet long or less.

These bridges are perfect candidates for details that will eliminate the leaking joint problem and significantly reduce such deficiencies. The FHWA TA recommends the use of jointless bridges "where possible."
